Slipstream Control Bar Leg Top Fittings Issue Date: 9/12/2005 Rev Date: na Page 1/1

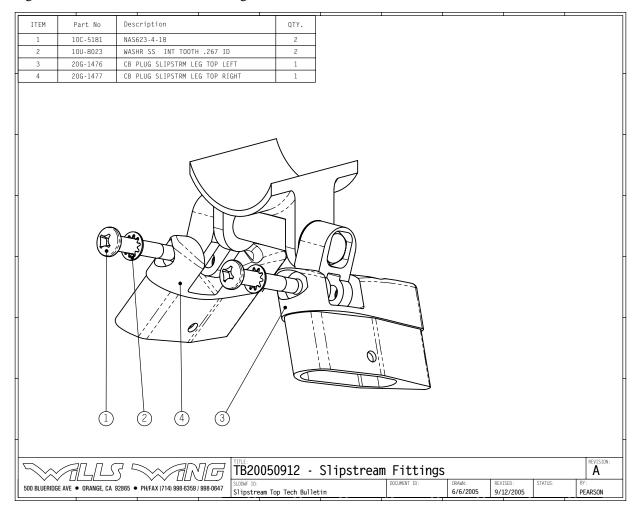
The machined aluminum top fitting used on the Slipstream and Carbon streamlined downtubes, and the similar bottom fitting used on early Carbon basetubes incorporate a threaded hole in the fitting into which a Phillips head NAS type bolt is installed. On the top fitting, this bolt secures the elbow to the top fitting (see diagram). We have had a few cases reported to us in which the threaded portion of the aluminum fitting has become damaged, allowing the bolt to back out. (On Litestream and Slipstream 2 fittings, the bolt is secured by a nut that fits into a slot in the fitting, and this advisory does not apply.)

All such threaded assemblies should be inspected to determine if the bolt is secure and the internal threads have been damaged or stripped. If the threads have been damaged, the fitting should be replaced. If the threads are undamaged, the bolt should be re-installed, using a drop of Blue Loctite #242 on the bolt threads, and making sure that the toothed lock washer shown in the attached drawing is installed as shown. Do not overtighten the bolt.
