Rear Leading Edge Replacement - All Models equipped with tip wands

On Talon rear leading edges, there have been three different methods used to secure the forward disk component of the wand receptacle assembly in the rear leading edge.

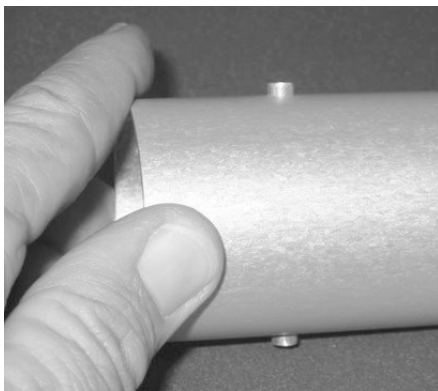
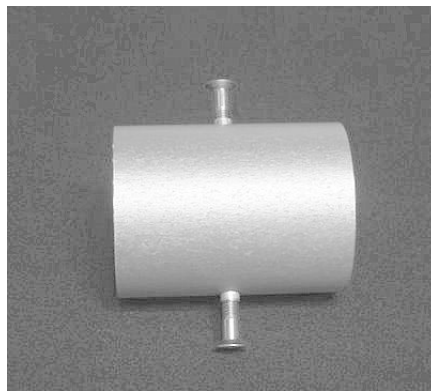
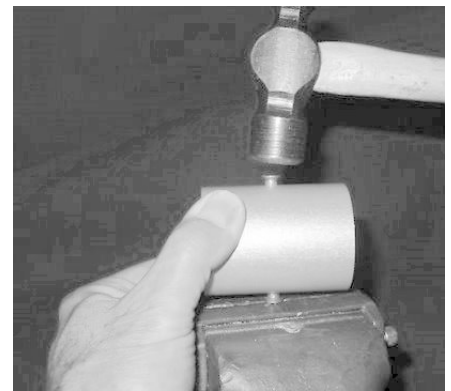
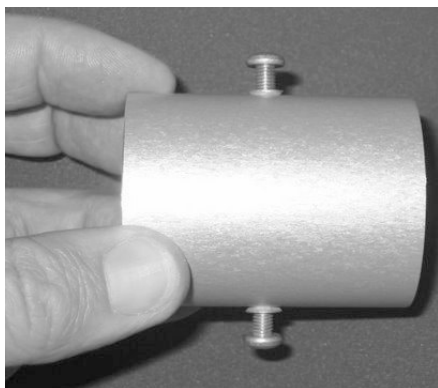
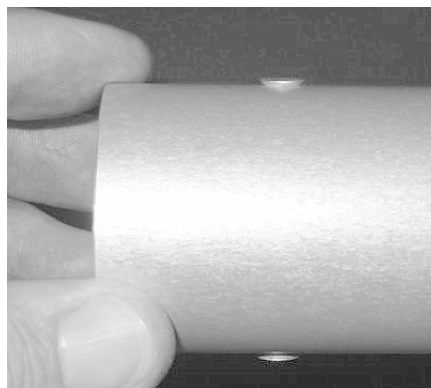
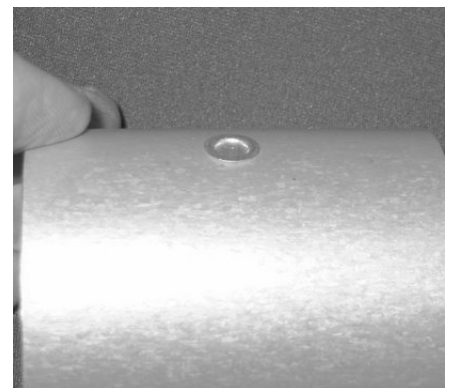
7. Note that the hole that secures the wand receptacle disk to the wand receptacle is slightly off center in the disk, to one side of the hole in the disk that secures it within the leading edge. Note also that the hole in

wand receptacle end cap is farther off center. When the assembly is properly oriented for installation, both holes are off center in the same direction, and the hole in the disk through which the clevis pin passes is vertical. The receptacle will point slightly outward when installed. If the disk is rotated 180 degrees, the wand receptacle will point severely outwards.

8. Set the rotational alignment of the disk and end cap so that on each the holes are off center in the same direction, as described above. Set the alignment of the disk so that the vertical hole in the disk is aligned with the vertical hole in the rear leading edge.
