Wills Wing Technical Bulletin

T2 Hang Loop and Spreader Bar Replacement

All Models T2

Issue Date: 10/19/2006

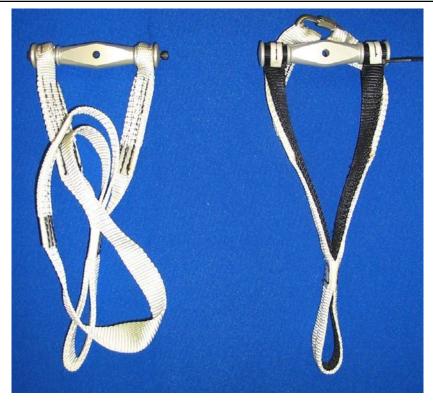
The first 50 or so T2's – those assembled through mid-July of 2005 – were made with the original T2 type hang loop and hang loop spreader bar and the non-swiveling support pillar, as shown below, left. T2's assembled between mid July 2005 and mid May 2006 were upgraded to the current type support pillar, which provides for the spreader bar to be rotated 90 degrees during glider breakdown, and reduces interference with and wear on the spars when the glider is folded up. This configuration is shown below on the right. The spreader bar and hang loop for both these configurations are the same – the spreader bar incorporates removable end caps which secure the hang loop to the spreader bar, and which are held on by self-locking Allen screws.

After mid May 2006, T2's were made with the same, 2nd configuration support pillar, but with a new, one piece spreader bar with integral end caps, and a new type of hang loop which fits tightly over the integral end caps and is then secured with plastic zip ties that pass through small webbing loops (picture on the following page shows the older T2 type spreader bar and hang loop on the left and the most recent, one piece spreader bar – hang loop assembly on the right).

On the original T2 type spreader bar, with the removable end caps, it is important not to over tighten the securing Allen screws, as they can be broken during installation or removal if over tightened. These screws are manufactured with a small patch of locking material to insure that they will not back out after installation, so if you have removed them to replace the hang loop, you should use a small amount of non-permanent Loc-Tite when you re-install them.

As shown in the second photo on the first page, the back up portion of the original T2 type hang loop is secured to the glider by larks heading the loop around the keel, underneath the sweep wire and VG ropes. On the most recent T2 type hang loop the back up portion is secured around the keel, and over the top of the sweep wire and VG ropes with a quick link. After installation, the quick like should be finger tightened, and then tightened not more than one quarter additional turn with a wrench. (The purpose of routing the backup loop over the top of the sweep wire and VG ropes is that this will provide an additional means of connection between the pilot and glider in the event of a failure in flight of the keel tube.)
