Sport 2 and U2 Sweep Wires made between 8/9/2016 and 10/3/2016, and possibly earlier.

**Background:**

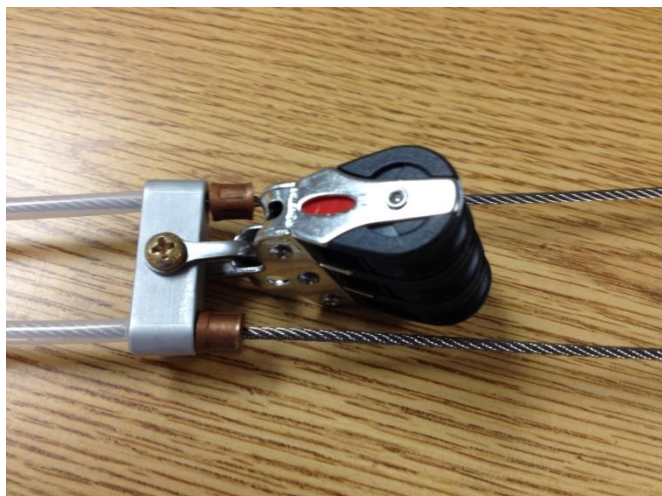
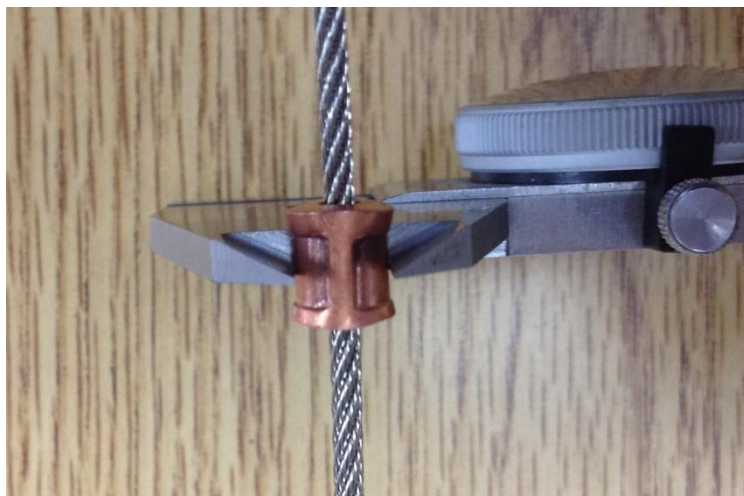
Refer to the photos below. We recently found that the red nico stops that secure the mounting of the rear triple block on the Sport 2 and U2 sweep wires were not pressed to the proper dimension on some gliders due to a malfunctioning nico press tool. Under load, when the VG is engaged, this can cause the nico stops to slip forward on the cable, changing the VG adjustment and reducing the VG range.

When pressed properly, the nico stop should measure 0.293 inches (7.44 mm) across the direction of the press (as shown above). The improperly pressed nico stops will measure 0.312 inches (7.92 mm).

Step 1 is to measure the pressed dimension of the red nico stops. If it is  $0.293 \pm .02$ , no further action is required. If it measures greater than .295, the wire should be checked for proper location of the stops, and if they are properly located the stops should be re-pressed to the proper dimension. This requires a nico press tool with a “J” slot. If the stops measure greater than .295 and are not in the correct location ( $\pm 0.2$  inches or 5 mm), the sweep wire should be replaced.
